# Manhole Inspection Summary

Manhole # S23KK\_029MH

**Location** Address: **1515 NORTH AVE**

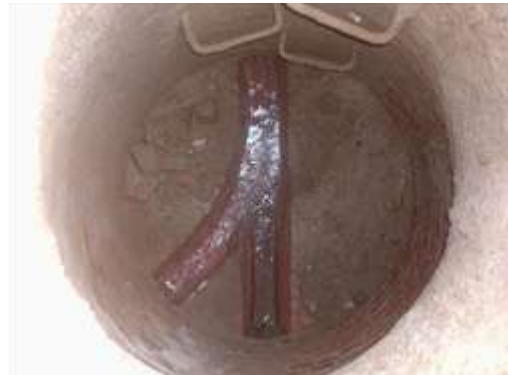
Top View

Corroded steps. Bench debris.

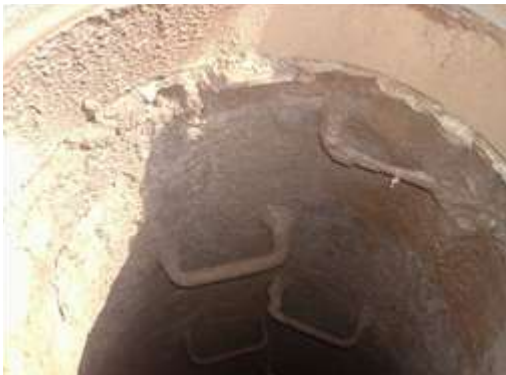
Defect

Frame leaks. Adjustment deterioration and infiltration.

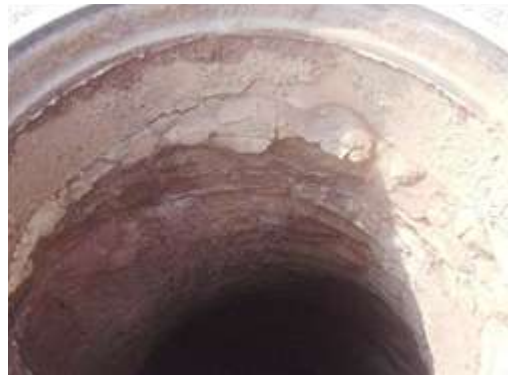
Defect

Frame leaks. Adjustment deterioration and infiltration. Barrel infiltration.

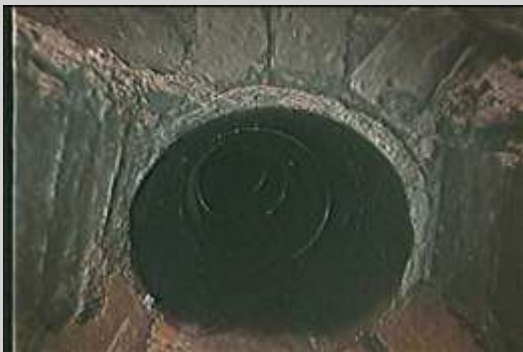
### 8 in. Circular Gravity Sewer Pipe Out @ 12 O'Clock

Infiltration: **None** Pipe Seal Cond: **Cracked**

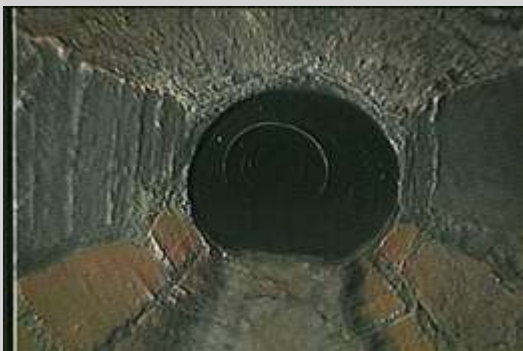
### 8 in. Circular Gravity Sewer Pipe In @ 6 O'Clock

Channel deterioration.
